JOHN WESLEY THEOLOGICAL COLLEGE

SPECIFICS OF COLLEGE DORMITORY LIFE'S QUALITY

(KTAK 136 - Environmental Certification and Condition Assessment - Semester project)

**John Wesley Theological College Hostel Inspection,
Dankó utca 11, 1086
Budapest, Hungary**

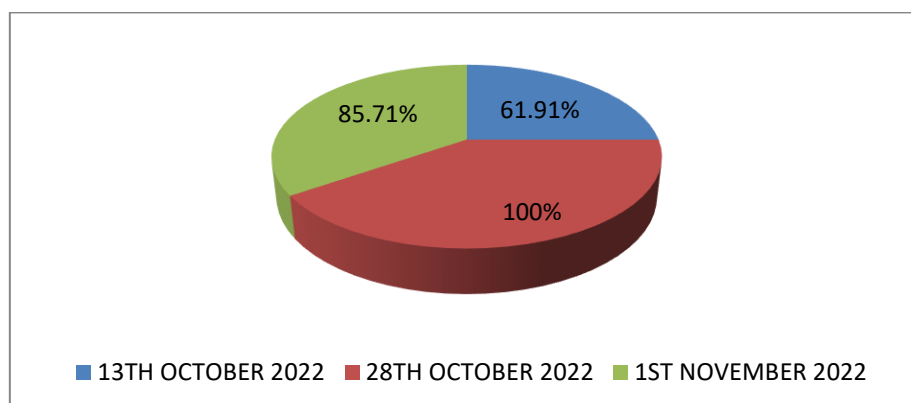
Fig. 1 The overall inspection results

7.1 Overall inspection results (Fig.1) by date:

JOHN WESLEY THEOLOGICAL COLLEGE HOSTEL INSPECTION	
DATE	SCORE
13 th October,2022	61.91%
28 th October, 2022	100%
1 st November, 2022	85.71%

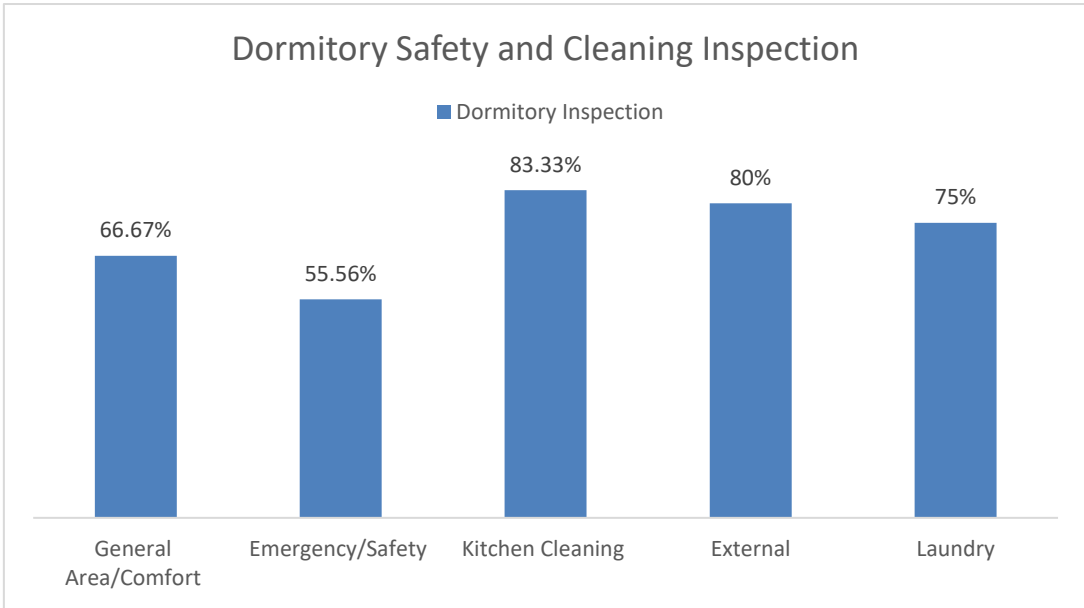
Fig 2 Dormitory Safety and Cleaning Inspection

Dormitory Safety and Cleaning Inspection (Fig. 2) reveals a high percent of kitchen cleaning, external and laundry and relatively good general area and comfort. The total score (Fig. 3) received after the audit inspection have shown a high degree of satisfaction.

General Area/Comfort: One problem in this section was about the noise level because it's a college and a humanity organization, so the flow of people working is big. The other problems is about the furniture almost all of them are old and some are broken.

Emergency/Safety: In this section the main problems are the electricity, fire orders and first aid. About the electricity, sometimes when more the one equipment is being used, we have power outage. And I couldn't find anything about the standard fire orders and first aid, so even though it's had firefighting equipment easily accessible, there isn't any information and instructions how to procedure in an emergency case.

Kitchen Cleaning: The main problem about the kitchen cleaning is the oven, even though the stove is properly cleaned every day, the oven isn't, and it has old grease stains that sometimes make cooking difficult and not safe.

Laundry: The main problem is about the electricity.

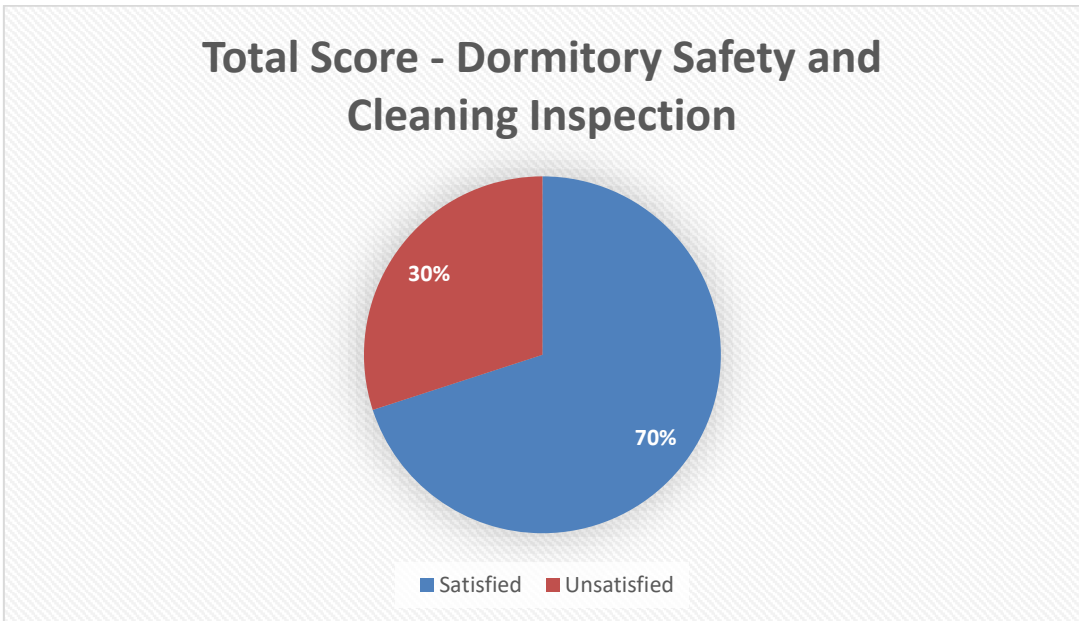
Fig 3 Total Score – Dormitory Safety and Cleaning Inspection

On an average scale, the hostel rooms and its environment per the audit report shows that the fire safety rules and measures, and the cleanliness are observed and followed. Though, more measures can be put in place to ensure an efficient and effective report.
